SURVEY & VALUATION

Your survey and valuation report

19 Minerva Way, Cambridge, CB4 2TY

16th November 2021

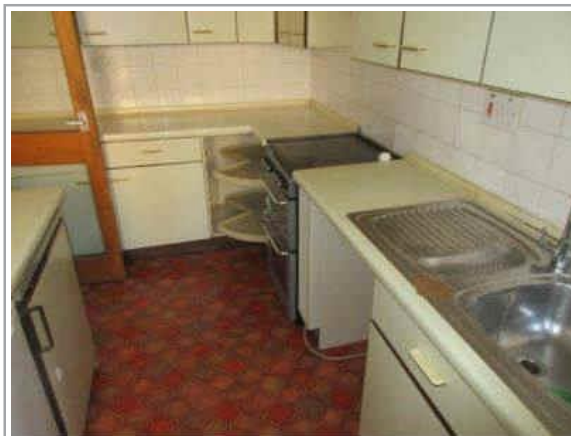
Kitchen

The kitchen units are in poor condition and you should be budgeting towards early replacement.

Condition Rating 3.

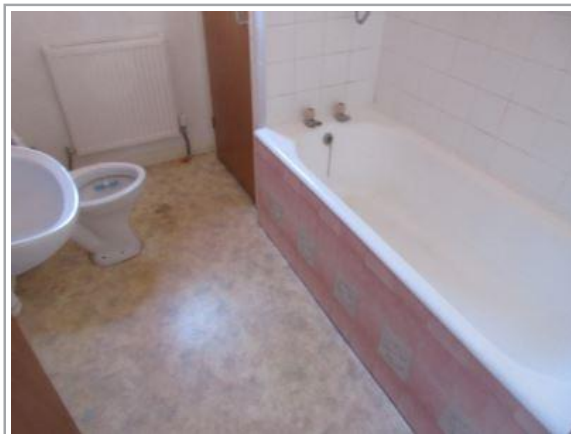
Bathroom

The flexible sealant around the bath is in poor condition and should be renewed. Defects may be present in concealed areas and we recommend that you inspect these as a precaution.

As previously mentioned the floor in the bathroom is rotten possibly due to leaking services and further investigations will be required.

Condition Rating 3.

There is insufficient ventilation in the bathroom and some condensation was noted requiring additional ventilation to be installed. Please see our comments in Section E9 below.
